STATE OF THE STREAMS

2021 WATER QUALITY SYNTHESIS REPORT

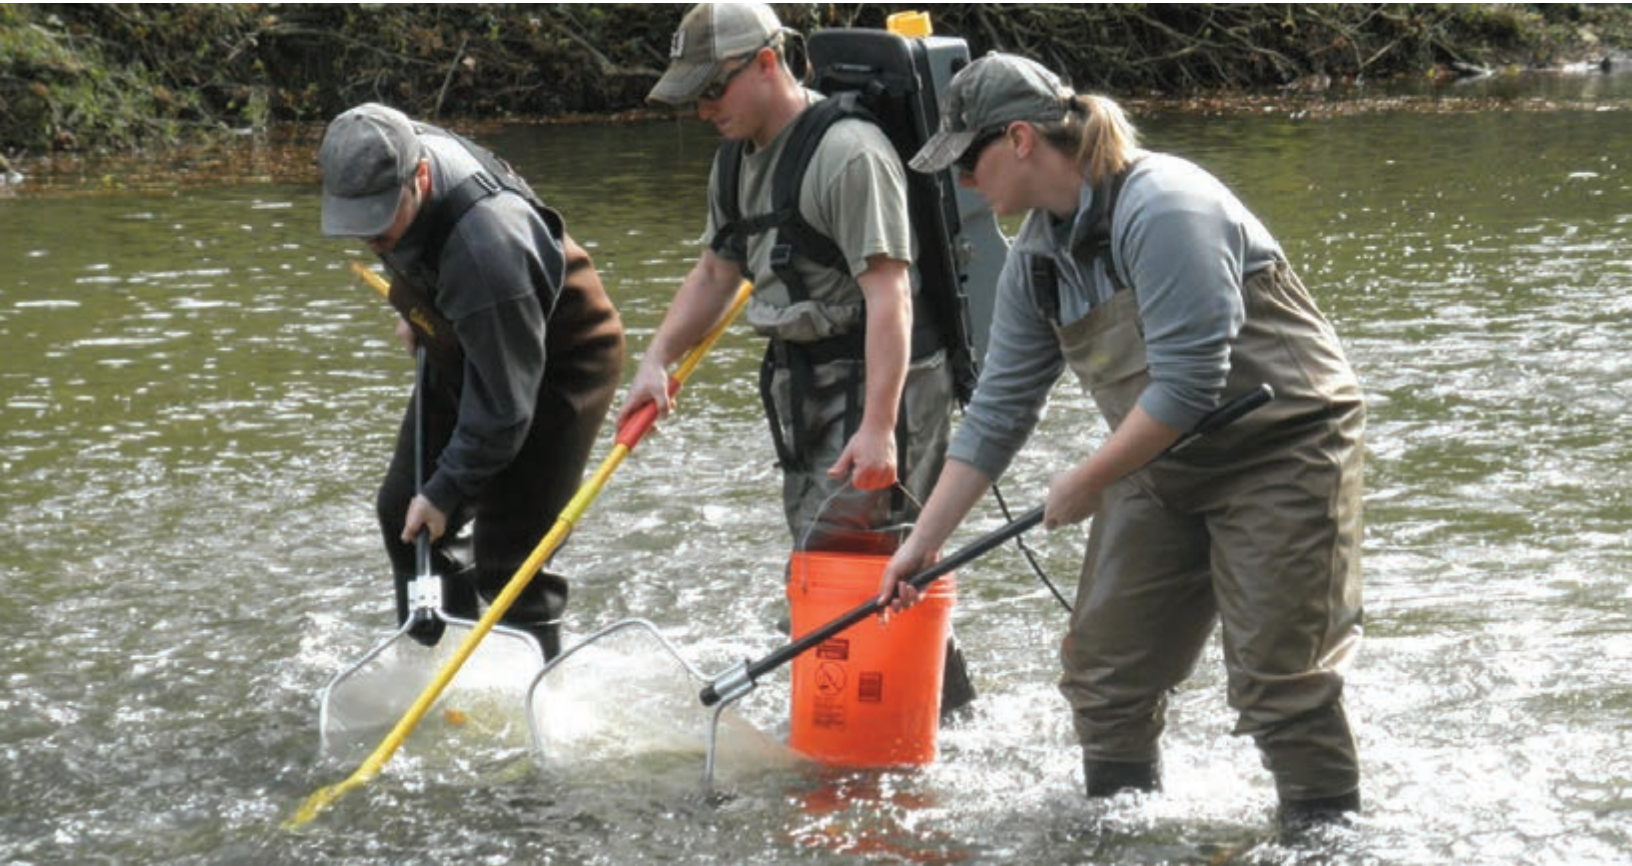
Fish are collected using a common scientific survey method known as electro-fishing. Electricity is used to stun fish before they are caught. This method is used to sample fish populations and normally the fish are returned to the stream unharmed in as little as ten minutes after being stunned. One person operates the equipment that stuns the fish while others catch the stunned fish with a net and place them in a bucket of stream water. The fish are identified and then returned to the stream.

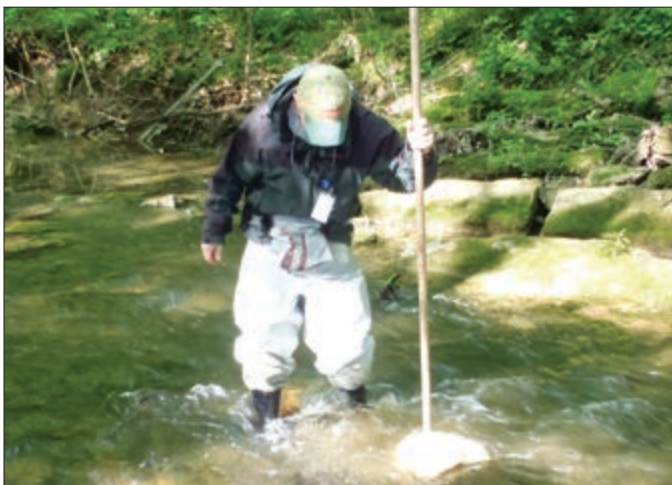
Biologist using a D-frame dip net to sample aquatic insects in a stream riffle

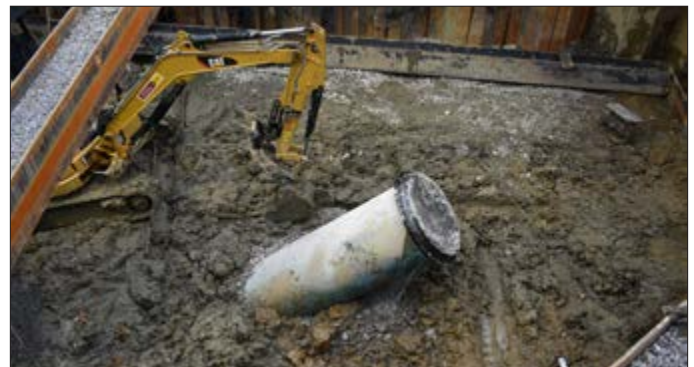
Harrods Creek sewer repairs

In 2019, MSD discovered a break in two sewer pipes along Harrods Creek. These breaks were causing sewage to run directly into Harrods Creek. MSD crews worked quickly to repair the breaks, but there were challenges due to the depth of the sewer and flooding from the Ohio River. Maintaining the sanitary sewer system is part of MSD's mission to provide safe, clean waterways. If you suspect a broken sanitary sewer, contact MSD's customer service at 502-540-6000.

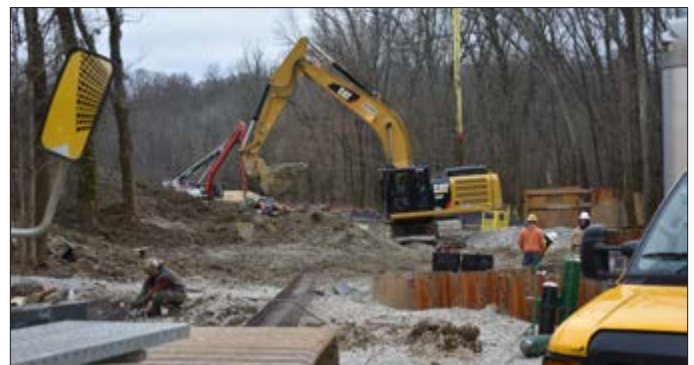
Shaft to access break along Harrods Creek

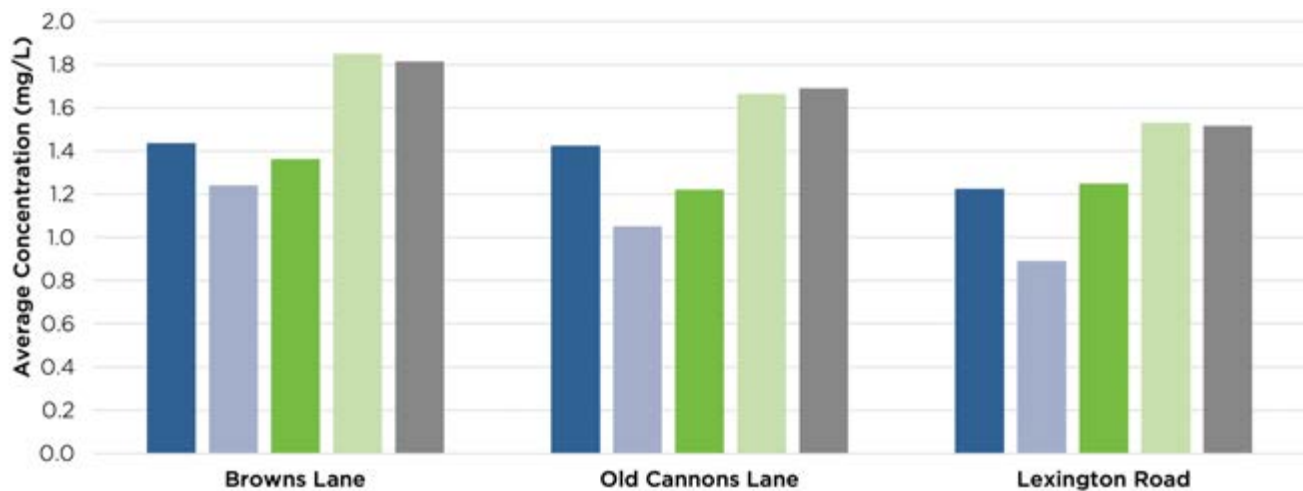
Nitrate + Nitrite in Middle Fork Watershed
Water Years (October 1 to September 30)

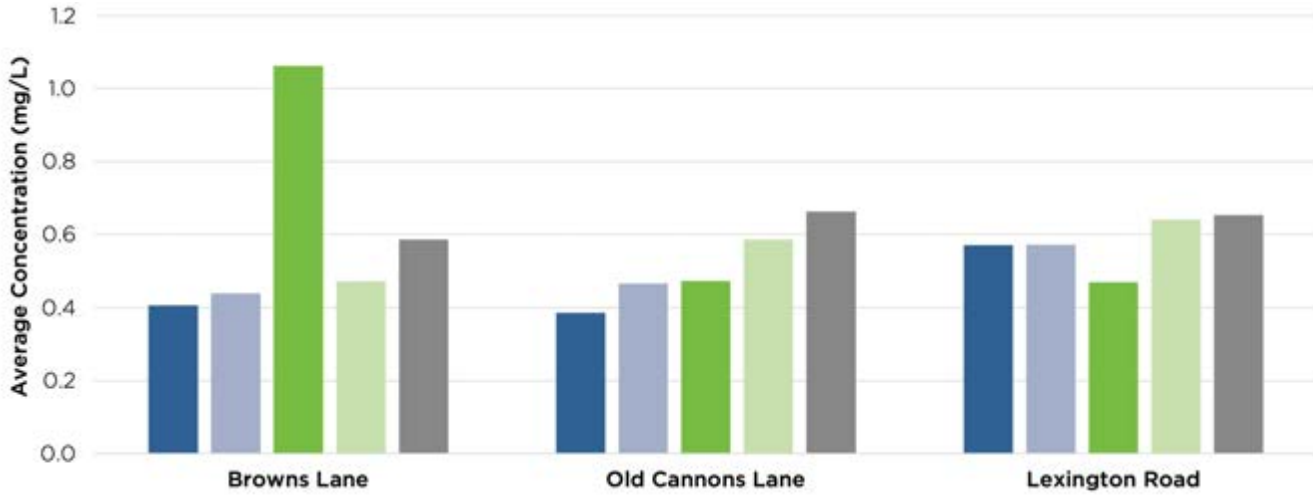
Total Kjeldahl Nitrogen in Middle Fork Watershed
Water Years (October 1 to September 30)

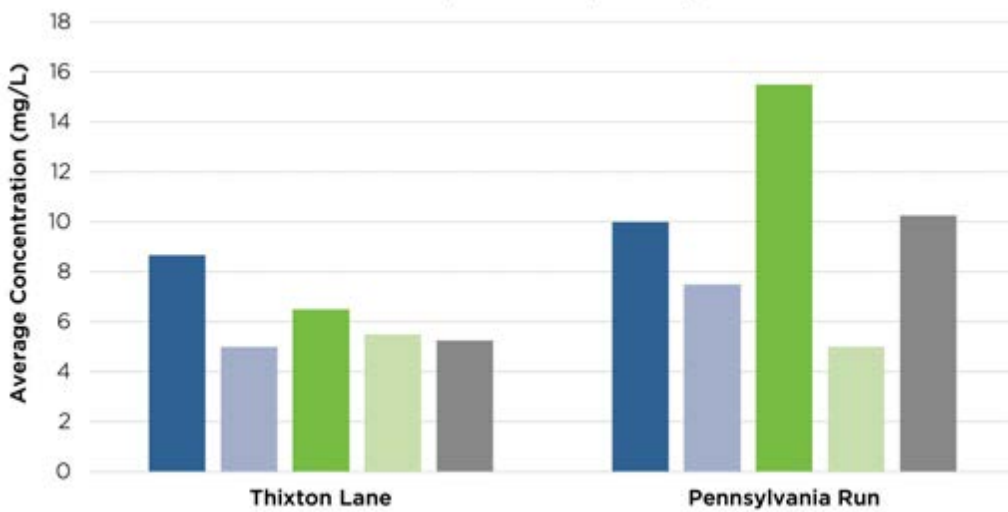
Total Suspended Solids in Cedar Creek / Pennsylvania Run Watershed
Water Years (October 1 to September 30)

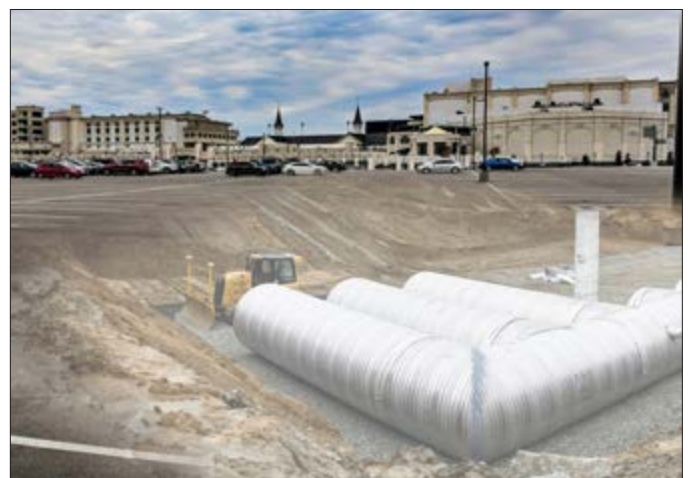
Green Incentive Infiltration Basin at Churchill Downs

Recent projects have included infiltration basins at the University of Louisville, Churchill Downs, and the Louisville Urban League Sports and Learning Campus and a sewer separation project at the Lynn Family Soccer Stadium. MSD has invested over \$42 million on green infrastructure projects that remove over 400,000 gallons of stormwater on an average annual basis.
